Intel® Celeron™ Processor Specification Update

Release Date: August 1998

Order Number: 243748-005

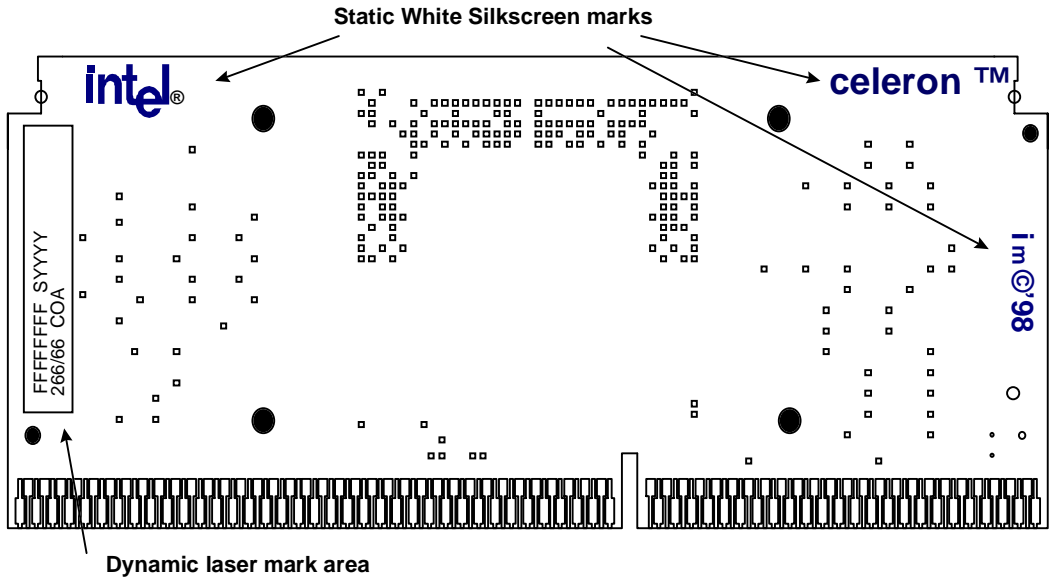
Intel® Celeron™ Processor Markings

- SYYY = S-spec Number.
- FFFFFFFF = FPO # (Test Lot Traceability #).
- COA = Country of Assembly.
